Ballan Church

BOLTED TRUSSES REBUILT

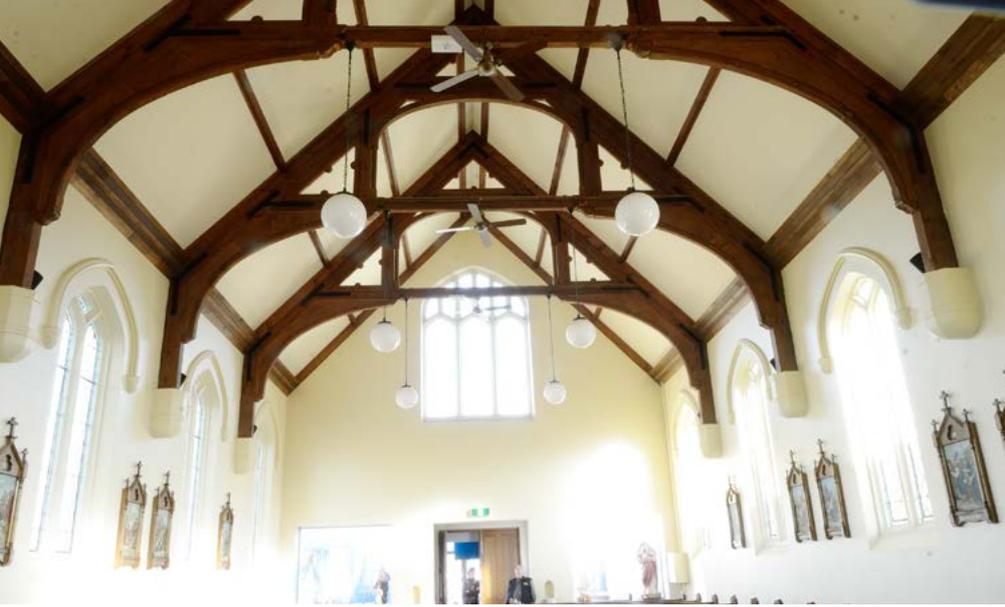
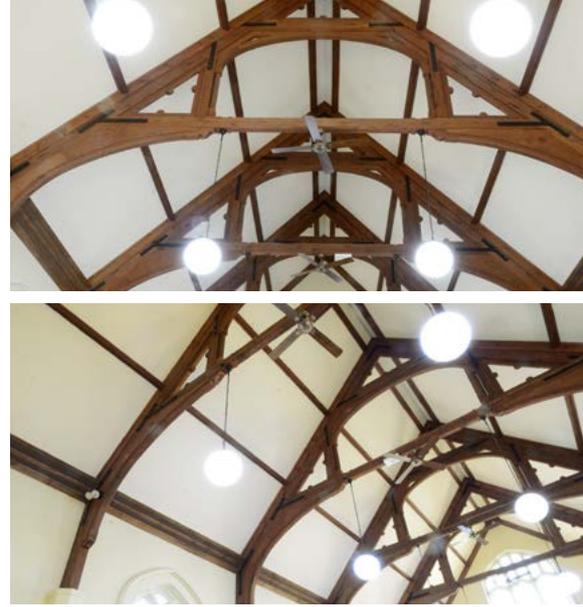
On April 8, 2009 St Brigids Catholic Church in Ballan, Victoria was destroyed by fire caused by an electrical fault. The interior of the church was gutted, though the original trusses were burnt but intact. This is one of benefits of using timber in the event of a fire. Because timber chars slowly, engineers are able to calculate the burn time of timber before it becomes structurally unsound.

Vicbeam were contacted to rebuild the trusses to as close as the original design as possible. The steel plates made by a blacksmith were salvaged from the wreckage and reused. Given that the steel was almost a 100 years old and handcrafted, however, there were a few peculiarities in each of the plates, they were not all identical. We had to adjust and manipulate each truss to suit.

Using GL13 Radiata Pine Glulam beams, we manufactured the timber and assembled the 4 trusses. The trusses included intricately carved timber that had to be precision made and then installed. Twenty Months after the fire, the church was reopened in time for Christmas 2010.
