Ballan Church

Bolted Roof Truss

BOLTED TRUSSES REBUILT

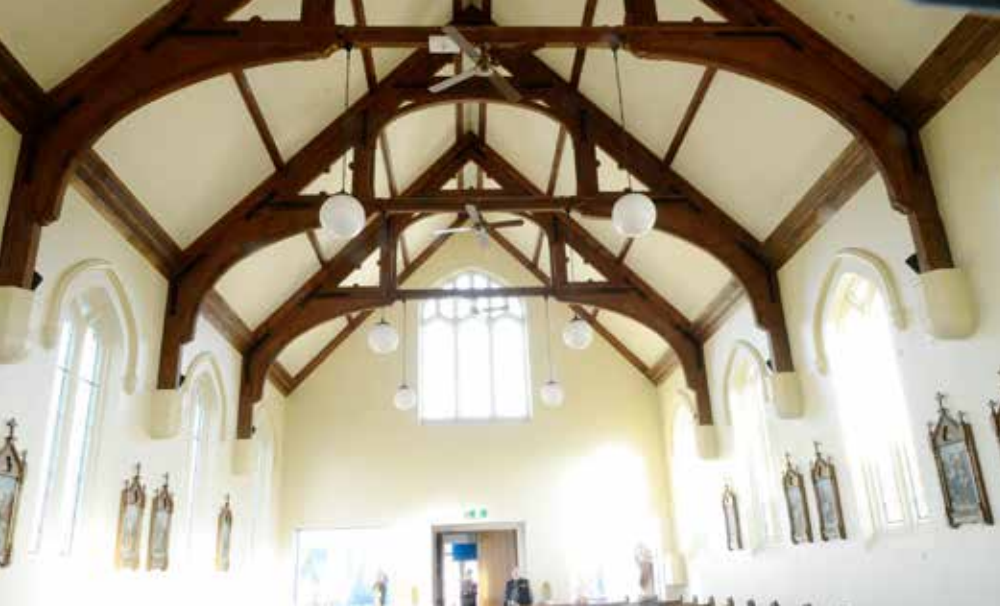
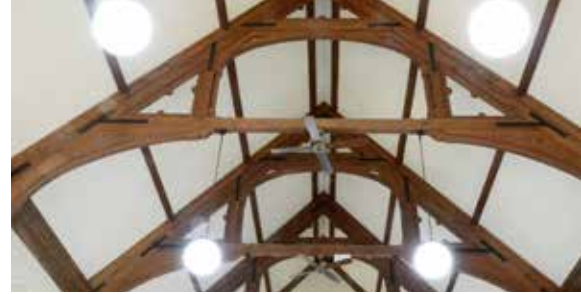
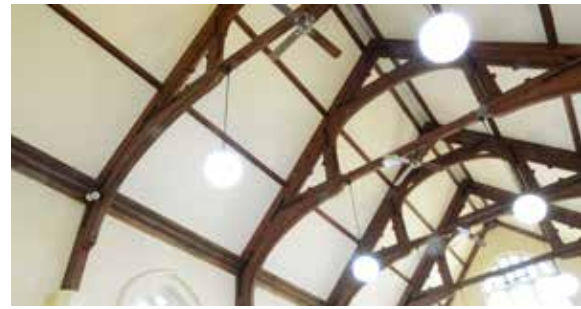
On April 8, 2009 St Brigids Catholic Church in Ballan, Victoria was destroyed by fire caused by an electrical fault. The interior of the church was gutted, though the original trusses were burnt but intact. This is one of benefits of using timber in the event of a fire. Because timber chars slowly, engineers are able to calculate the burn time of timber before it becomes structurally unsound.

Vicbeam were contacted to rebuild the trusses to as close as the original design as possible. The steel plates made by a blacksmith were salvaged from the wreckage and reused. Given that the steel was almost a 100 years old and handcrafted, however, there were a few peculiarities in each of the plates, they were not all identical. We had to adjust and manipulate each truss to suit.

Using GL13 Radiata Pine Glulam beams, we manufactured the timber and assembled the 4 trusses. The trusses included intricately carved timber that had to be precision made and then installed. Twenty Months after the fire, the church was reopened in time for Christmas 2010.
