Lynwood Country Club Pergola

A PERGOLA STRUCTURE BUILT FOR A PLAYGROUND AND ITS MAGNIFICENT GOLF COURSE VIEWS

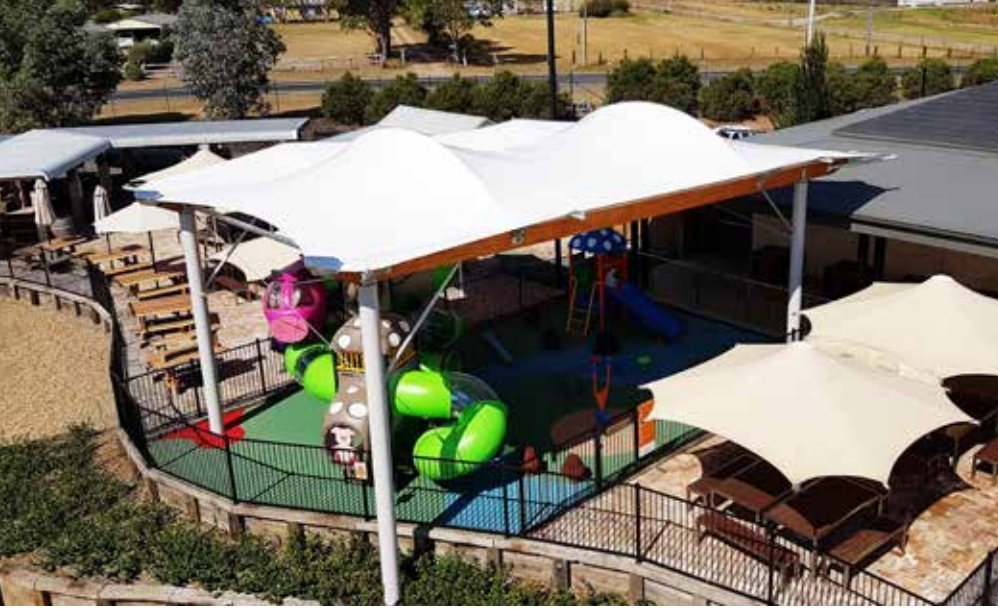
GL13 Radiata Pine has been H3 treated and coated with two layers of Cutek Extreme, providing highly resistant rafters that is also protected from decay, rot and insects. The pergola structure is dominated with steel poll connections bolted together to provide a stable frame and support of two timber rafters. Its timber texture adds a nice touch to the white tone of the tensile fabric cover.

The arched tensile fabric ensures a cover ideal for all weather conditions. It also offers the benefits of acoustic comfort from outside noise and provides an ideal temperature for playing activities and sports.

Vicbeam are proud to have worked with a business that is recognised internationally. SMC2 is a global company that specialise in engineering multi-scaled pergola structures for a range of sporting arenas. The pergola project required Vicbeam to fabricate and deliver 13.0 metre rafters ready for assembling on-site.

Although small in comparison to other projects, this pergola structure is aesthetically pleasing with its combination of white steel connections and excellent inclusion of timber texture. This is a great example of a project designed using the best materials for pergola structures to date.
